Foster Branch Watershed Survey Sediment Source Evaluation

Harford County Department of Public Works
Water Resources Engineering

May 1997

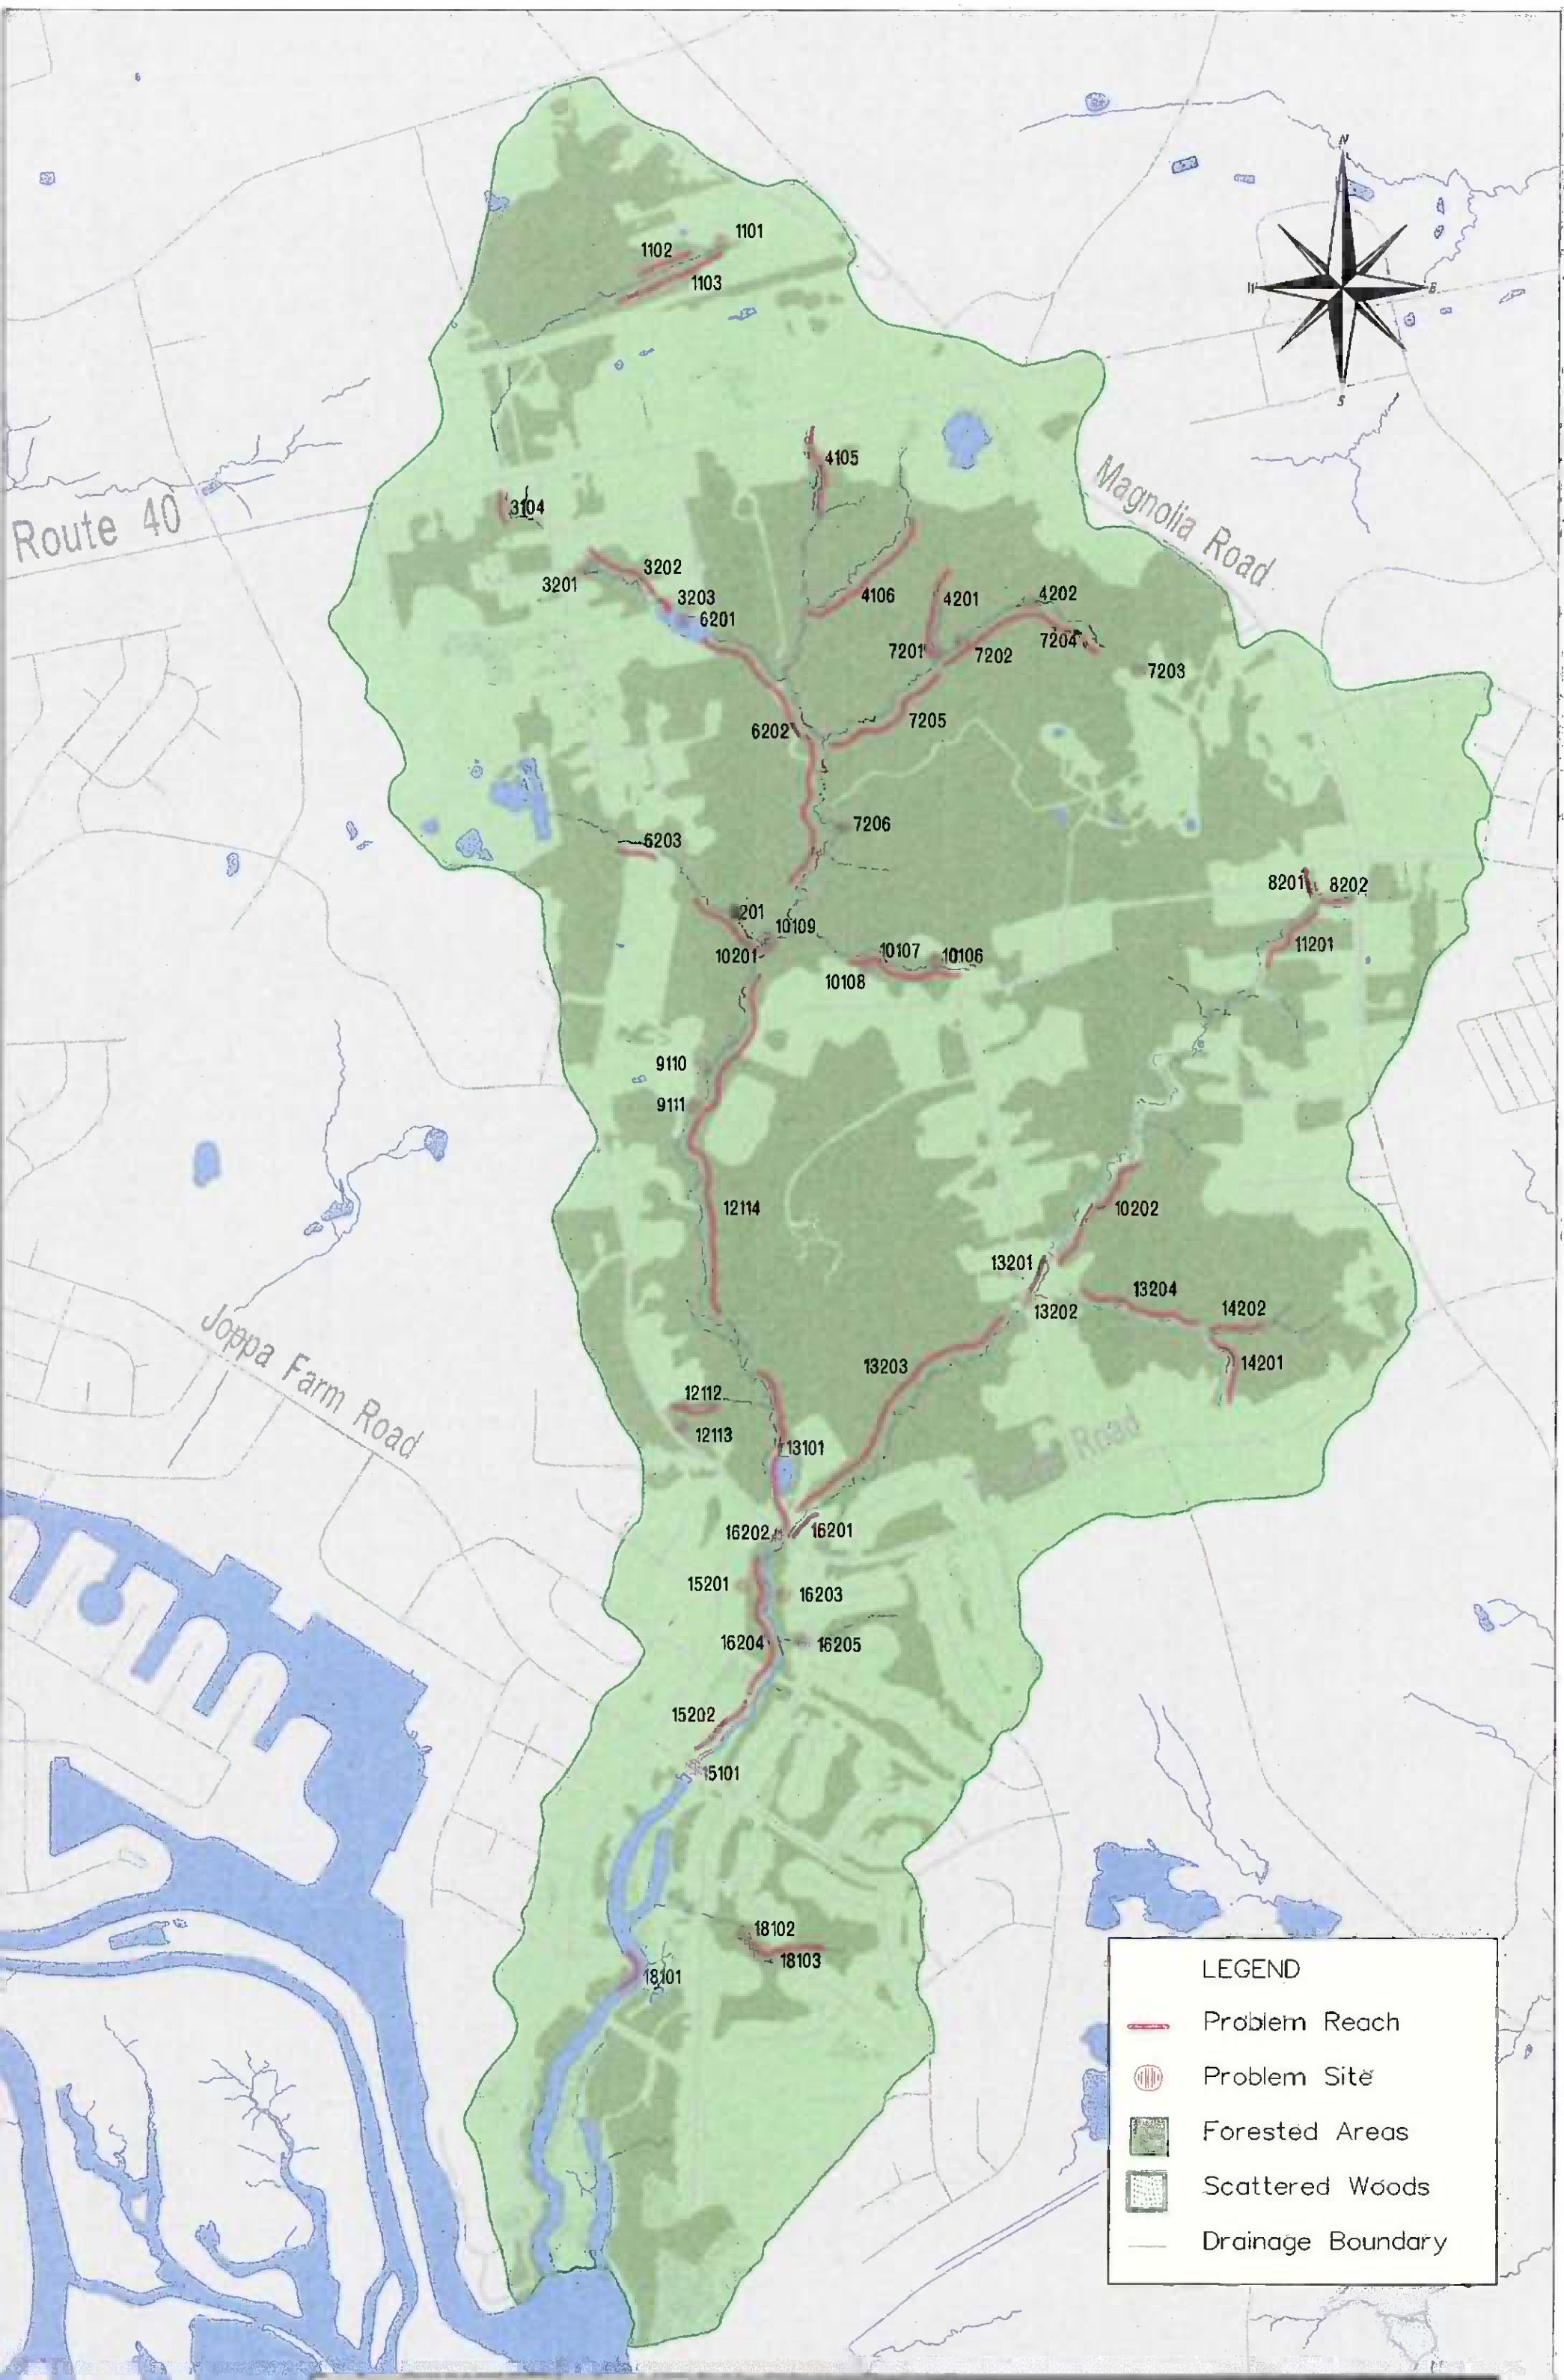
Foster Branch Watershed Study Problem Priority 1

Table 1 lists the alternatives that would address the worst erosion problems. Figures 3-8 show individual problem sites.
